A Critical Investigation into Microplastic Accumulation, Transportation and Physical Processes in the Marine Environment in and around Langstone and Chichester Harbours, Central Southern England.

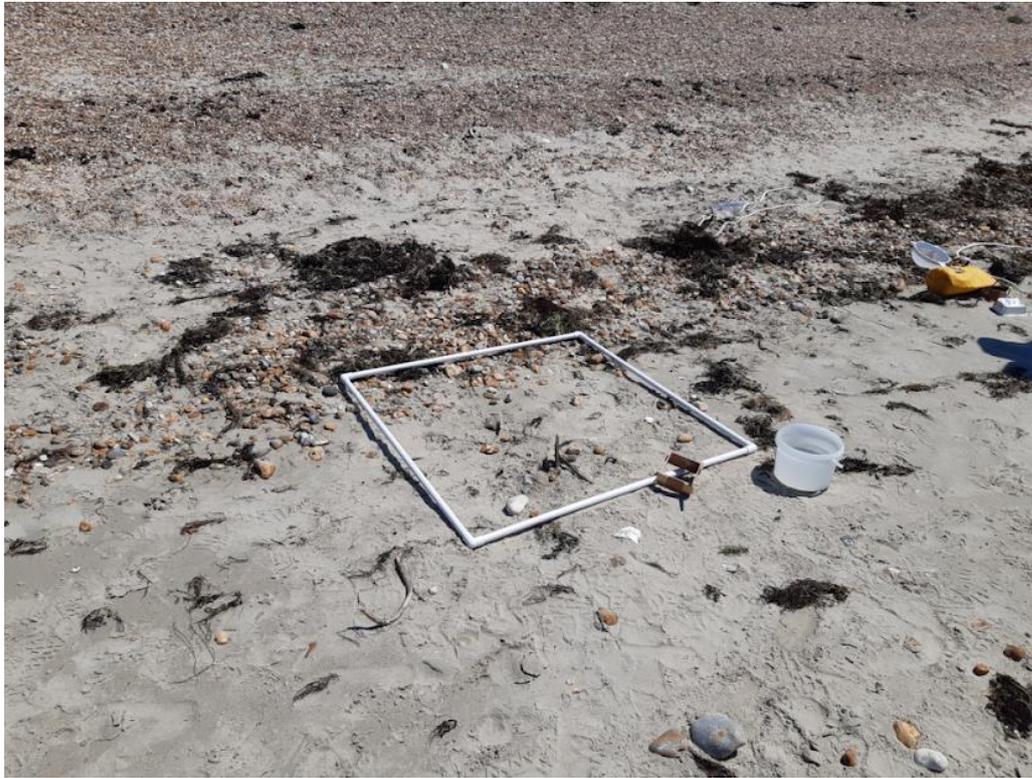
Figure 2 - Example of the equipment used on site, showing both a 1m² and 10cm² quadrats and a bucket for sediment separation. The sample being shown is taken from a strandline on West Hayling. Source: Author's own.

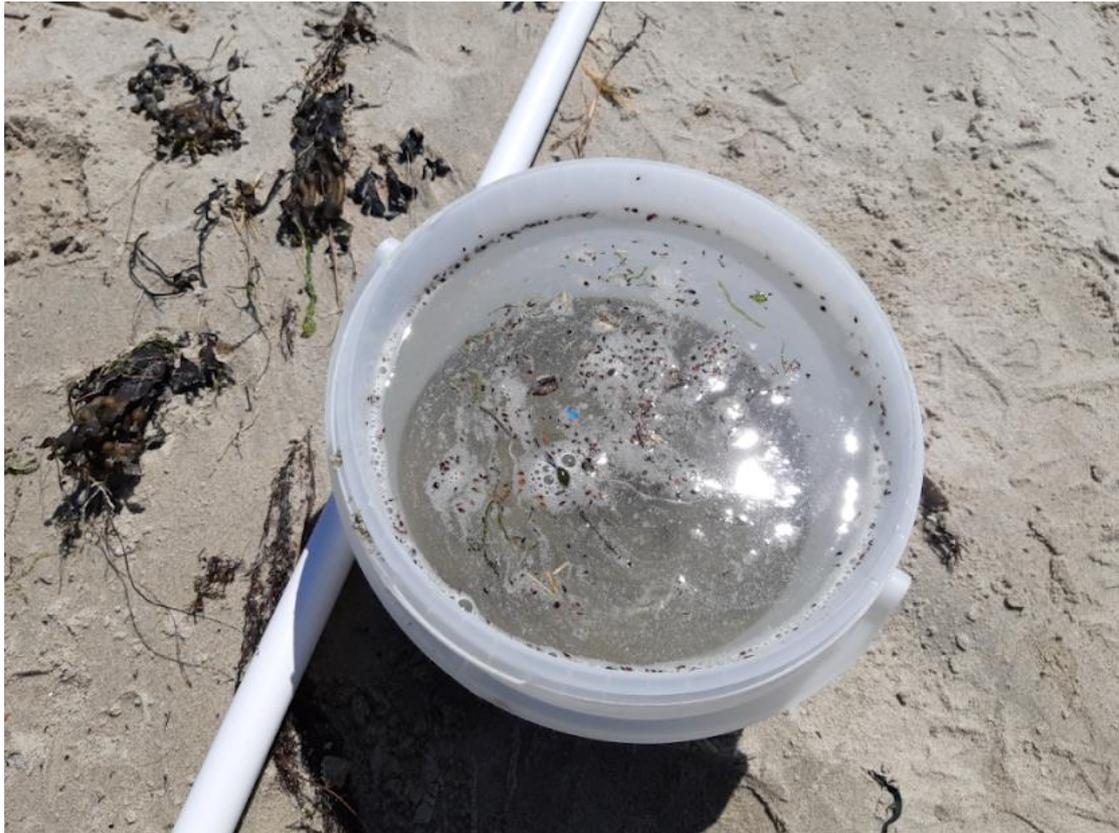
Figure 3 - Separation of sediment and plastic pieces using water filtration on site. Source: Author's own.

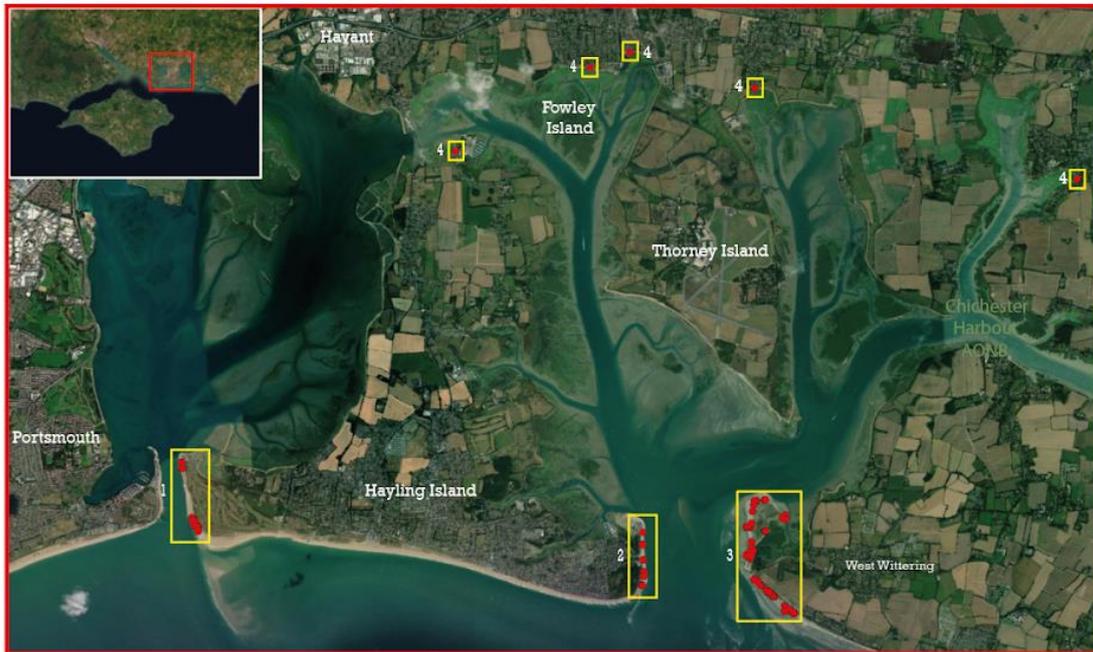
Figure 4 - Map of all the sample sites investigated and their locations. West Hayling Island Beach (1), East Hayling Island Beach (2), West Wittering Beach and East Head Spit (3) and Chichester Harbour (4). Source: Author's own.

The complete data table for the total 122 sites can be viewed in Appendix (A), as well as the micro and mesoplastic count averages used to create Figure 5. It should be noted the particularly high number of sample sites at the West Wittering Beach and East Head Spit sites compared to the others. Not only are these sites easily accessible, but the majority of David's work with volunteers

and studies into citizen science have taken place here, thereby leading to this network of sites.

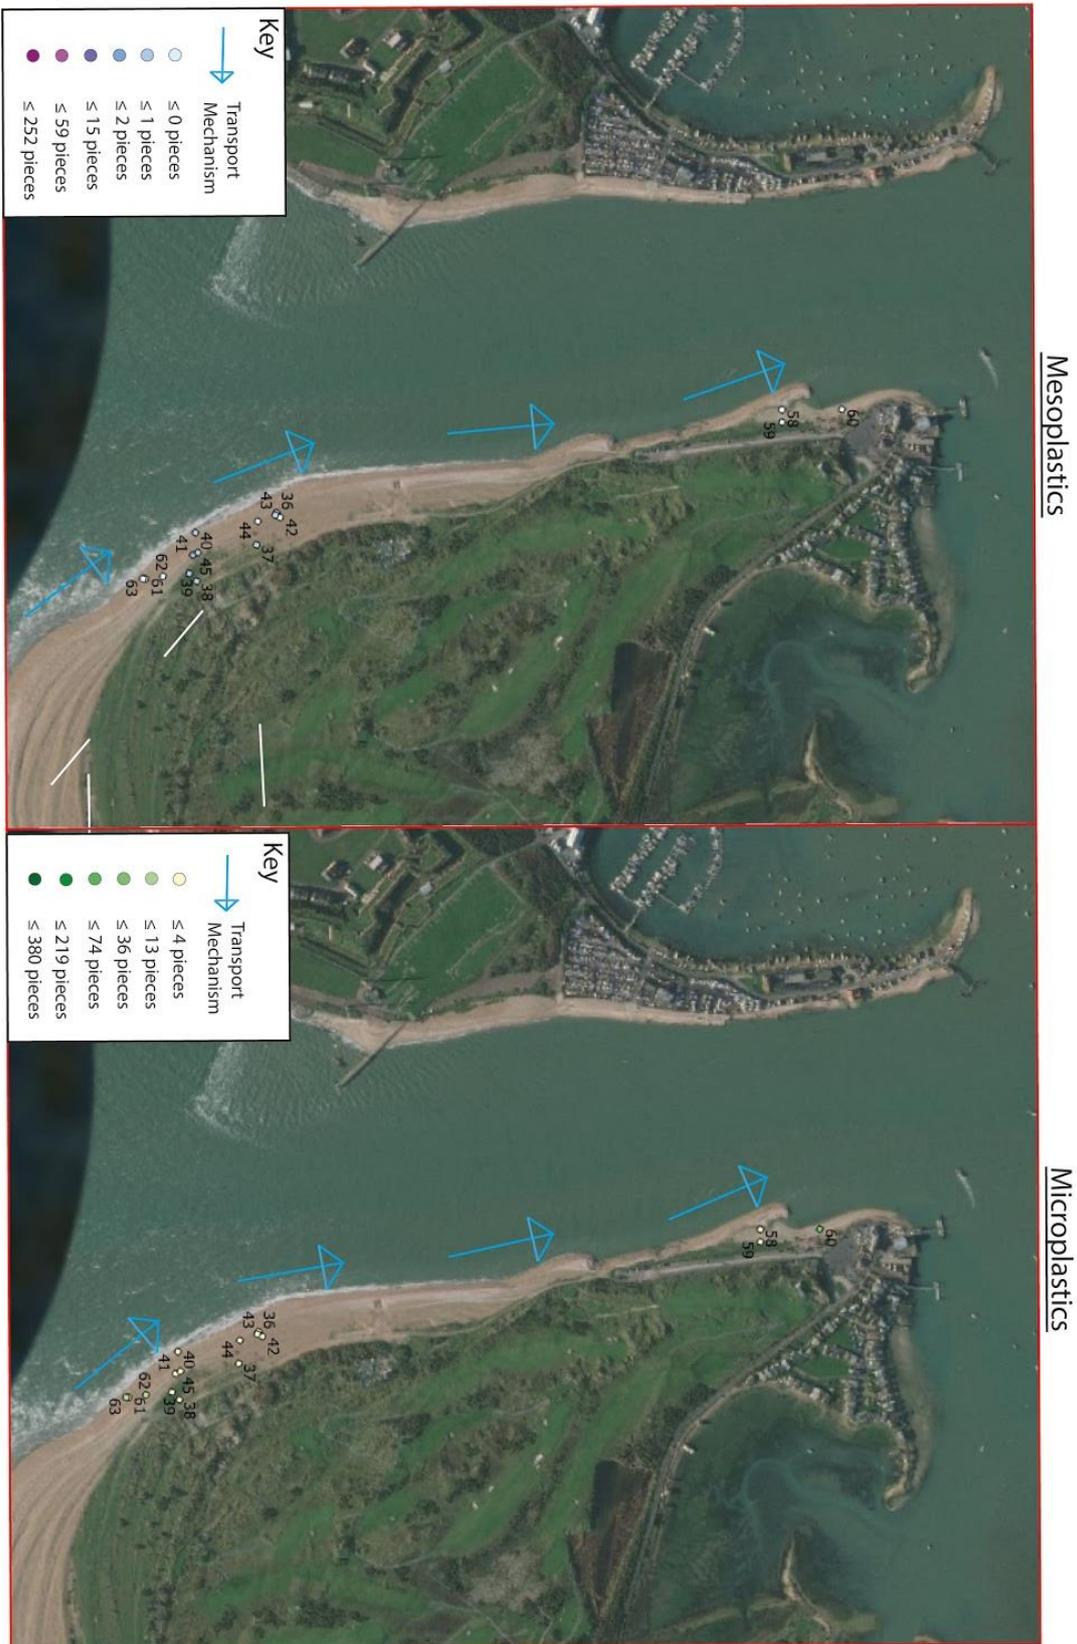
Figure 8 - Maps of the sample sites taken from the west of Hayling Island beach, with meso and micro plastics values shown separately. Transport mechanisms have been overlaid on the study area for visual aid from SCOPAC (2012a). Source: Author's own.

Site 60, as the northern most sample site in this area, has a much higher number of microplastics at 18 pieces collected. This result is expected given the dominant transport process in the area being littoral beach drift in a northerly direction. Floating microplastics, being moved via Stokes drift along the beach, could settle here, especially in the lee of a sand dune just south of this site (Figure 12). This would point to this area being a sink for microplastics, further backed up by the sand dune at this site, showing this area is already a sink for coastal sediments in the sediment budget. The SCOPAC (2012a) sediment transport study notes that erosion of sediment at Gunnar Point and subsequent transportation northwards has led to this build-up on the eastern side of Langstone Harbour entrance. Page 134 of beach profile analysis by HR Wallingford Ltd (1995) showed this northward drift using results that displayed erosion at the apex of Gunnar Point, and subsequent build-up of sediment further in toward the Langstone Harbour entrance. This fits with relation to the low microplastic amounts in the southerly direction of the beach, as pieces here

Sites 62 and 63 also have higher microplastic amounts than average, at 7 and 13 respectively. These two are the most southern of all the samples taken at this site. The higher microplastic amount here could indicate a temporary sink, where microplastics would accumulate due to weak erosive energy being unable to remove it. The lack of mesoplastic at these sites further shows this sink is exclusive to microplastics due to their smaller size, but could also be due to beach clean-up groups focusing on mesoplastic pieces.

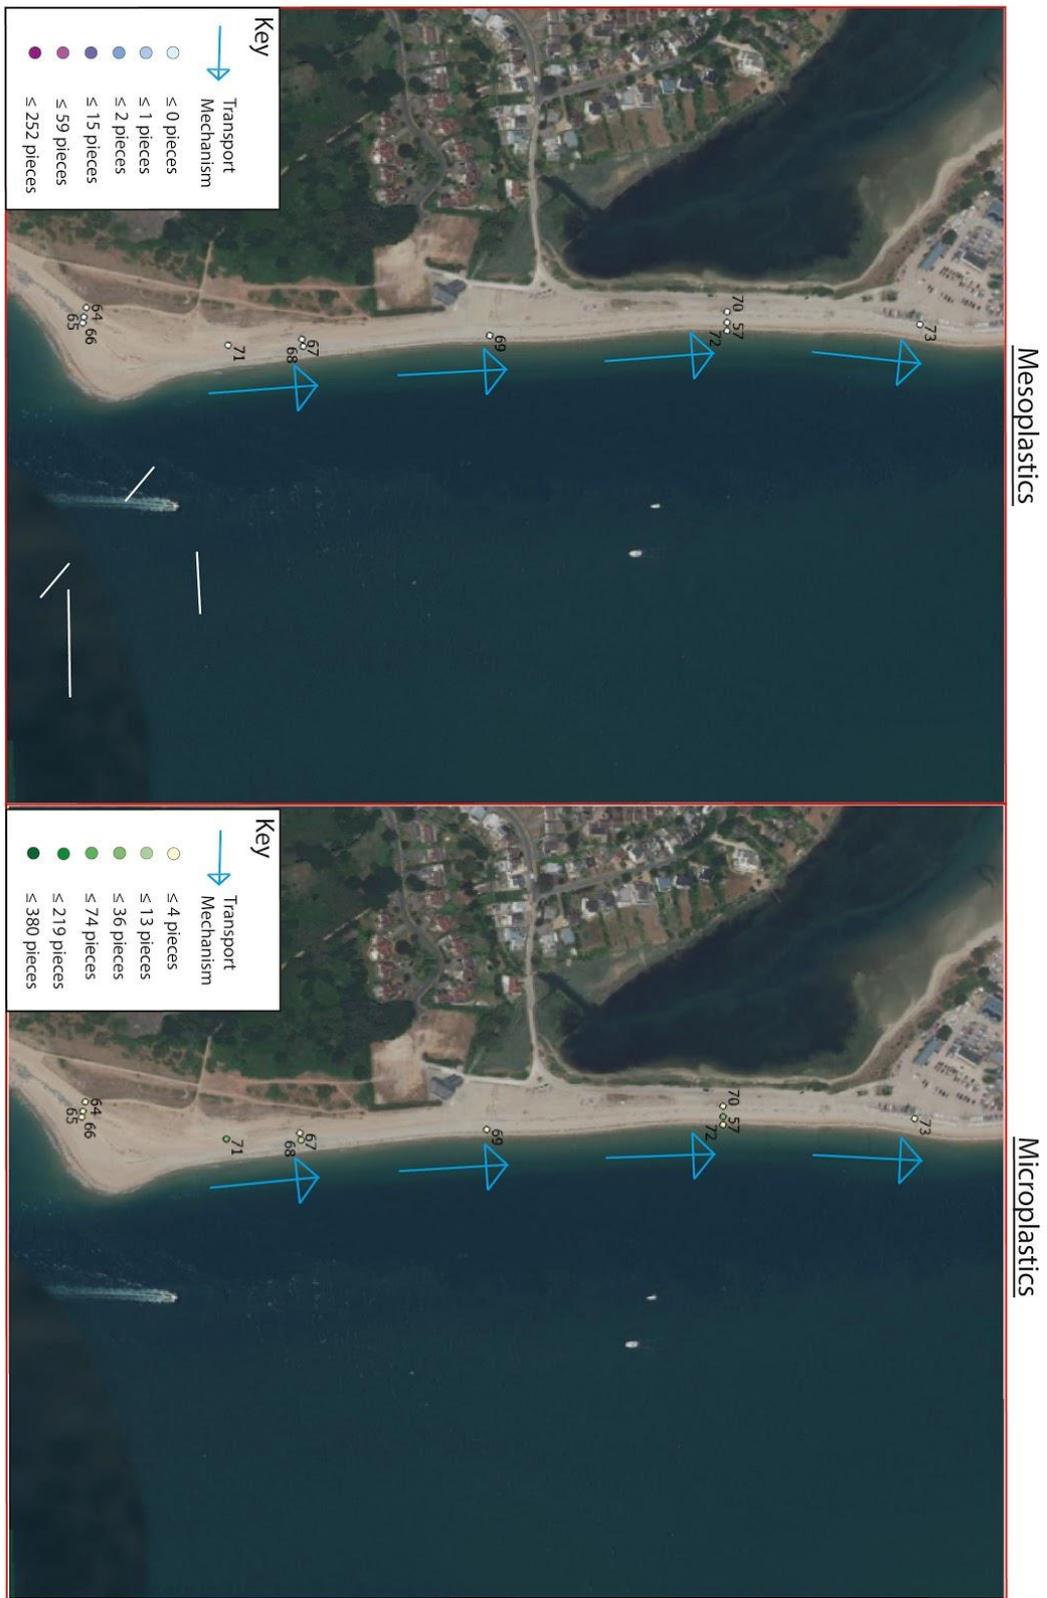
Figure 9 - Maps of the sample sites taken from the east of Hayling Island Beach, with meso and micro plastics values shown separately. Transport mechanisms have been overlaid on the study area for visual aid from SCOPAC (2012a). Source: Author's own.

The expectation, as with west Hayling Island Beach, is that the northern most sample site will have the highest number of microplastics found. This is not the case. Site 57 shows the highest accumulation of microplastics at 56 pieces discovered. This site is located at an exposed area towards the upper end of the beach. The reasoning for the higher microplastic amount is believed to be due to wooden groynes along the beach in this area. The establishment of these coastal defences is intended to reduce sediment transportation and erosion of the shoreline, and to allow for build-up of sediments. In the same way, microplastics could build-up here along with sediment, trapped by the shelter from the groynes and forming a microplastic sink. Groynes represent a human influence on the sediment budget of the coast, disrupting sediment transport processes. This would prevent the further movement of microplastic along the beach, as represented by the low number found at site 73.

36 microplastics were found at Site 71, the second highest for this area. This site is around midway between the sea and the back of the beach. The reasoning for this higher amount of microplastics is unknown, but could be an indication of local factors impacting the movement of plastics. It is theorised that being located in the lee of Eastoke Point from the south could shelter the site

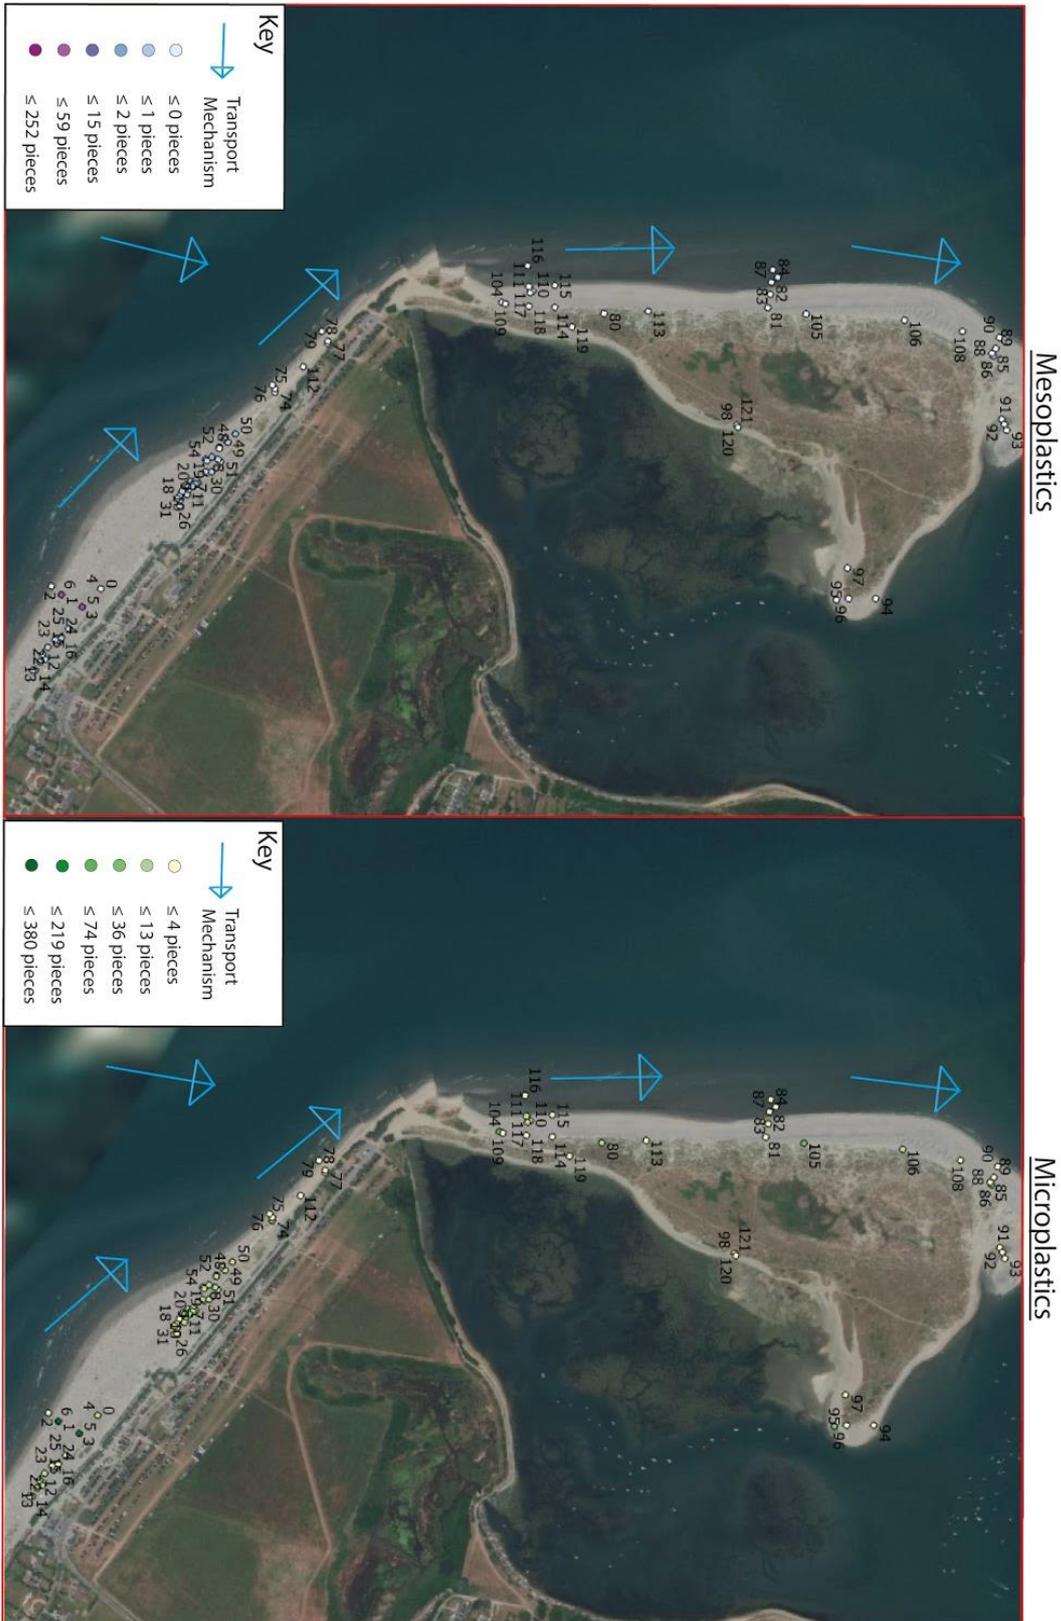
Figure 10 - Maps of the sample sites taken from West Wittering Beach and East Head Spit, with meso and micro plastics values shown separately. Transport mechanisms have been overlaid on the study area for visual aid from SCOPAC (2012a). Source: Author's own.

Hayling Island. This has resulted in the formation of East Head Spit, as sediment being transported westwards is forced to become deposited. At West Wittering beach, the vast majority of sites have greater than 13 microplastic pieces, with a handful of sites in the eastern group of sample sites having microplastic counts of over 200. Secondary microplastics made up 40% of the plastic found, and mesoplastic numbers were higher in the same location. This area is extremely popular with tourists in the summer months, with 15000 visitors expected on particularly busy days (West Wittering Estate, n.d.). As such the litter they bring can be left in these areas. Sand dunes in this area are likely to entrap these plastics and prevent their movement via wave or aeolian processes. Furthermore, the drift rate of sediment here is lower than areas eastwards down the coast, at 1-3000m³ per year (SCOPAC, 2012b). This would make it easier for sediments, and by extension microplastics, to become entrained here and stuck in a sediment sink.

Sample sites from the East Head Spit beach have generally lower plastic amounts found than at West Wittering. Due to the groyne installed at the neck of the spit after the erosion of this area in 2004 (Chichester Harbour Conservancy, n.d.), transport of microplastics through surface sediment transport mechanisms to the spit from West Wittering is unlikely. Aeolian transport processes are shown to dominate here (SCOPAC, 2012b), moving sediment in a southerly and south-westerly direction landward and resulting in the accumulation of sand dunes on the spit. These have become established with specialized dune vegetation, and are protected to prevent trampling. It can be theorised that microplastics on the beach would be carried by this aeolian process in the same manner as sediment and become entrained in the sand dunes, forming a microplastic sink. Jones (2018) noted in his study that although sampling was not possible within the dunes, microplastics could be seen there in abundance.

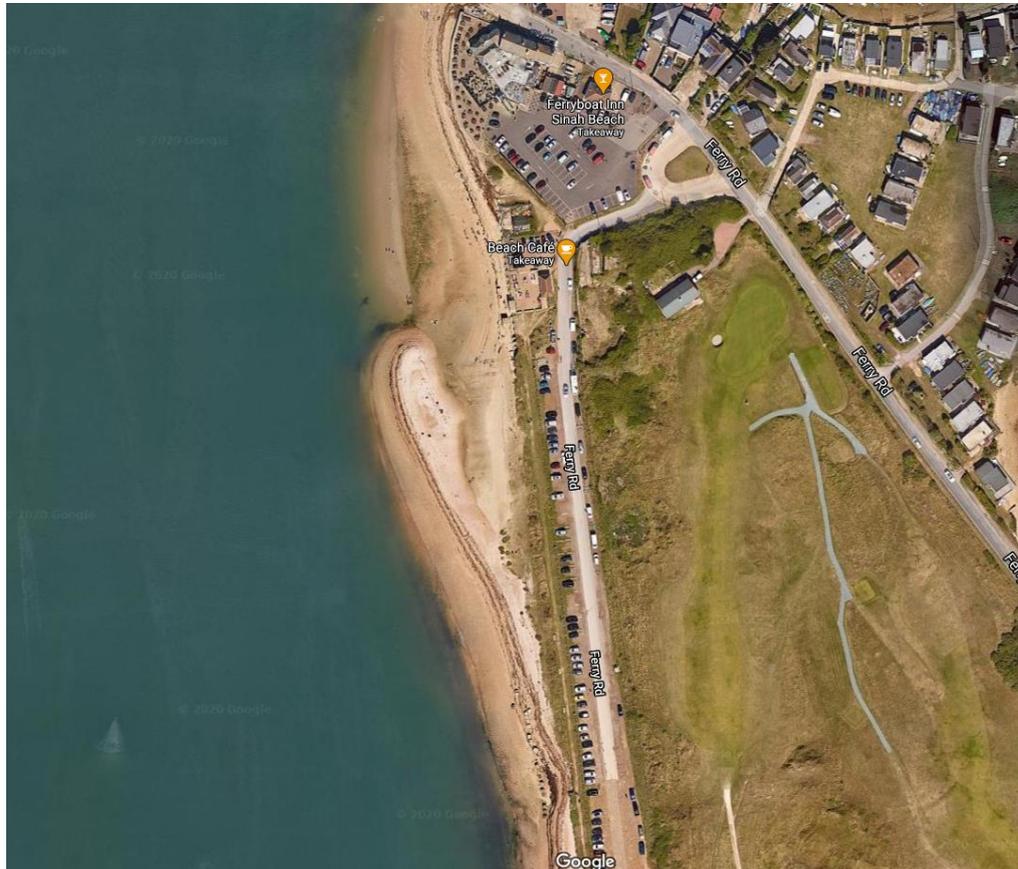
Figure 12 – Overhead view of the area just south of the Hayling Island ferry and surrounding site 60, showing the sand dune that protects it from coastal processes. Source: Google Earth (2020).

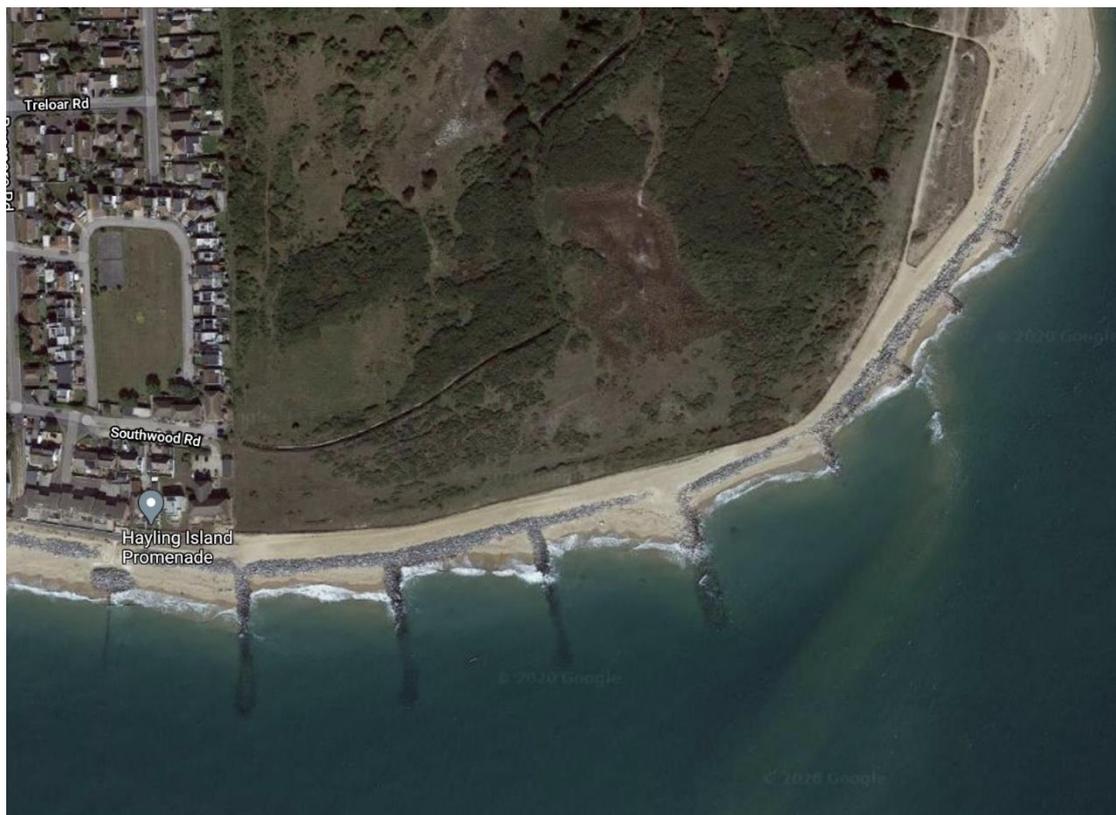
Figure 13 - Overhead view of Eastoke Point and the rock groynes found there. Source: Google maps 2020.

Sites 64-66 at Eastoke Point have very low microplastic counts, which is likely due to the presence of rock groynes at the site and further east (Figure 13). Any sediment and microplastics from the beach moving by wave or aeolian processes would become trapped here, hence the low microplastic amounts at the 3 sites.
