BSc (Hons) Geography with Marine Studies

ASSESSING THE QUALITY OF BATHING BEACHES AND THE ROLE OF SEASONALITY IN TOURISM ON THE ISLE OF WIGHT: A COMPARATIVE STUDY

April 2017

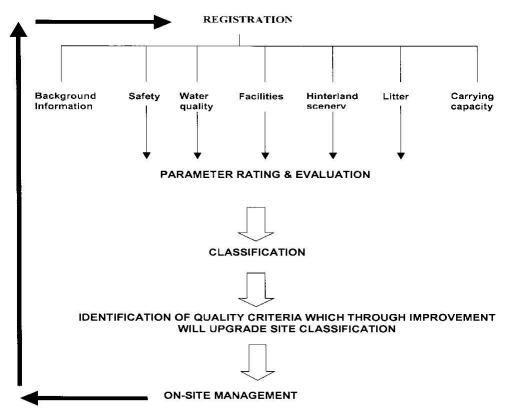
Figure 7: How the BARE system works, Williams et al. (2009)

Morgan (1999) created a checklist to evaluate beach areas based on many factors. This checklist incorporated a range factors deemed important to beach users. After, Williams et al. (2009) devised a beach star rating system. This method includes parameters of Safety, Water Quality, Facilities, Litter and Scenery. There are also a range of physical and human factors (see Appendix 8.1) these parameters are based on the main aspects which affect beach user happiness. (Figure 7)

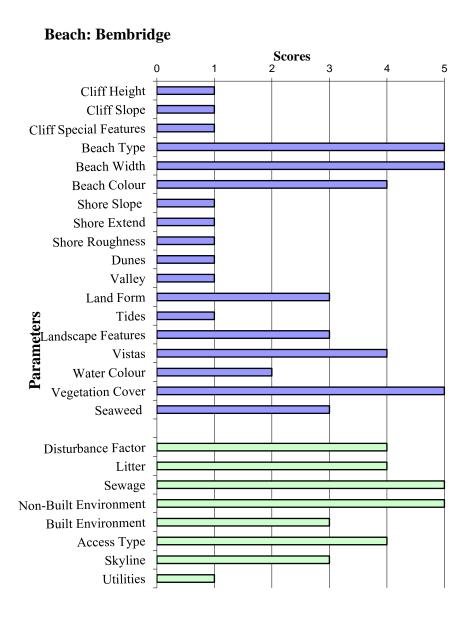
Figure 8: Fuzzy logic histogram for Bembridge Beach, (Source: Author)

During the coastal scenery evaluation, certain parameters can be subject to 'vague concepts' based on human nature. The fuzzy logic theory assesses the possibility and degree of each factor considered. (Ergin et al., 2004)(a) The significance of each factor is based from data produced by questionnaires carried out in the UK and Mediterranean, which concluded that litter, water colour, noise, built environment and coastal landscapes were at the top of beach users' priorities. An example of fuzzy logic is shown in Figure 7.

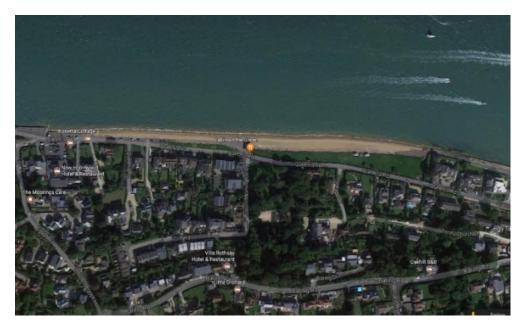
Figure 9: Aerial View of West Cowes, (Google Maps, 2017)

West Cowes is a small width pebble and shell beach. (Figure 9) facilities and scenery were the main factors which needed improvement here. Due to the proximity of the road to the beach, noise at this location was not a problem identified. This location would benefit from more accommodation, and this could economically benefit the area during events such as Cowes week. Although there is a café and beach shop in high season, these were not open on the day the assessment was completed. Clean showers and restaurants were also not available and again this would bring not only more facilities to the beach users, but more income in this area from tourism. Safety was another parameter that was highlighted as important, as there was a lack of safety parameters at the location.

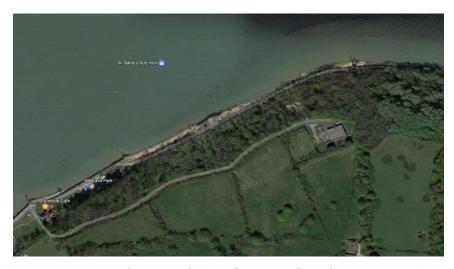
Figure 11: Aerial View of East Cowes, (Google Maps, 2017)

East Cowes is an urban beach, which is situated 10 minutes from the ferry terminal. As seen in Figure 11, the beach is backed by fields and woodland. There was a lack of many facilities such as restaurants, sunbeds, showers and wheelchair access. There is however a small café, which was closed on the day, therefore deemed unavailable. There was also a kids play area, picnic area and campsite. East Cowes had a fair amount of facilities concentrated in one area. Safety was an issue here also, awarded a 'C', lifeguards were not present and there was no bather zonation. There was also a lack of first aid posts. If the safety, facilities and scenery increased then the beach would achieve a higher rating.

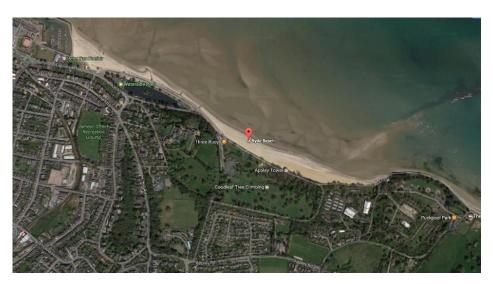
Figure 12: Aerial View of Ryde, (Google Maps, 2017)

Ryde was one of the top scoring beaches. The beach had many safety and facility features, and it was apparent that a lot of work had been put into the signage and information that visitors could find there. The facilities that were missing were sunbed hire, and umbrella hire. This could be due to time of year, or them not being in demand at this location. The scenery at this location was sensitively designed, as there was a diverse mix of accommodation, facilities and environmental areas.

The beach was not busy when visited out of season, but most if not all necessary facilities were open and available. In the summer months, it was predicted that this beach would be very popular with tourists, therefore adequate beach cleaning would need to be in place to cope with the increased amount of waste. The scenery score was generated from several factors, and if it were to increase to 'B' then the beach would have an increased star rating.

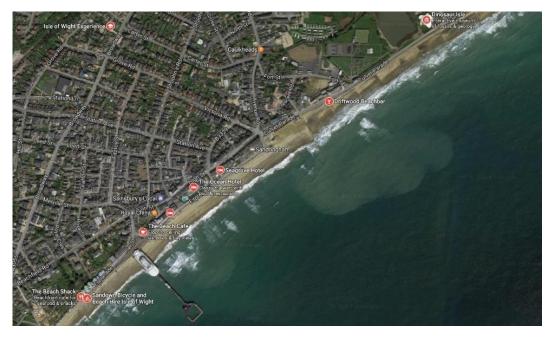
Figure 13: Aerial View of Sandown, (Google Maps, 2017)

There was a high amount of development and housing around Sandown beach. (As shown in Figure 13) There were many facilities available during summer seasons, such as deck chair hire, sun loungers, wind breaks and beach huts for hire. However, these were not available on the day. Alongside this, there was also storage of kayaks and water sport equipment on the beach front, suggesting that although it may not have been used recently, it was present. The main issue at this location was litter, and this may have been due to the seasonality, meaning the beach was cleaned less frequently out of season.

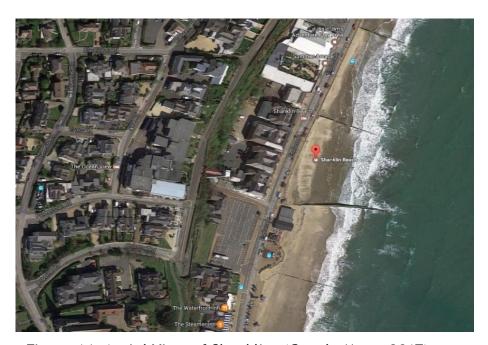
Figure 14: Aerial View of Shanklin, (Google Maps, 2017)

Shanklin was a sandy beach, with a promenade, housing many summer activities. For example, there was a café, toilets, disabled toilets, a shop, beach hut hire and a first aid point. There was also an arcade, and adventure area. However, the play area was shut, and there was no sunbed hire. This location is very popular with tourists in the summer, hence why there are so many places to accommodate them. There were information boards about the beach, and its history. However, there was an absence of public showers. The balance of natural and built environment was well designed and there were relatively low levels of litter.

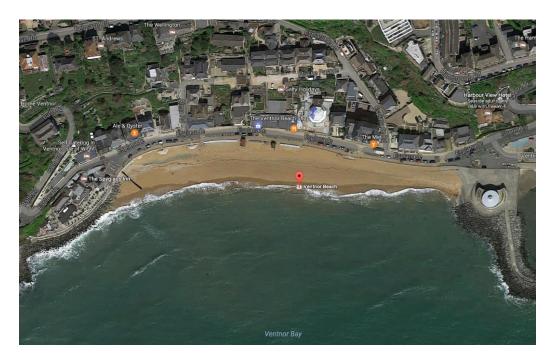
Figure 15: Aerial View of Ventnor, (Google Maps, 2017)

Ventnor was a mix of shingle and sandy beach, with many facilities, as seen in Figure 15. There were several facilities which cater to tourists, however few of these were open on the day. The main issue in terms of scenery here is the proximity of cars and passing traffic, alongside the parking also. There was a lack of lifeguards on the day, along with no zonation markers. There was also a lack of sunbed hire and other high season based activities.

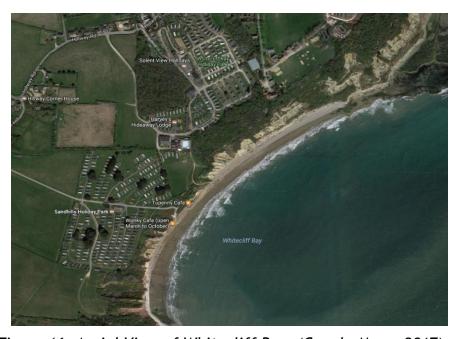
Figure 16: Aerial View of Whitecliff Bay, (Google Maps, 2017)

Whitecliff Bay beach was a long, sandy beach located at the bottom of steep cliffs (as shown in Figure 16) this beach was connected to a holiday park, which made access difficult. The access to the beach was limited for the public, and was more catered to the people staying in the caravan site. The scenery here was natural, with long sandy expanse and high cliffs. The main areas of interest were safety and facilities. There was a lack of lifeguards and zonation markers, alongside first aid posts. The absence of lifeguards may be due to the seasonality, as there were few people on the beach during the assessment. Also, due to its lack of public access, there may not be a need for lifeguards at that time of the season. There was hardly any litter on this beach, and this again could be due to lower numbers of visitors. The café was closed on the day of the visit, and there were little to no tourism based facilities such as sun bed hire or toilets. This may be since the beach is at the back of the caravan park, and the average visitor there does not need these facilities because they can go back to their caravan for showers, toilets and refreshments.

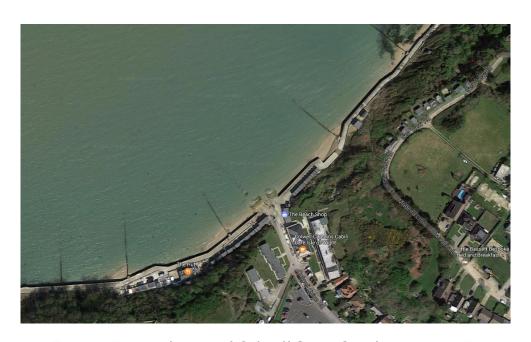
Figure 17: Aerial View of Colwell Bay, (Google Maps, 2017)

Colwell Bay is a popular village beach, and the surrounding area is home to accommodation, cafes and shops. The overall layout of the beach is detailed in Figure 17. The beach had apartment complexes and was one of the beaches that had many amenities backed into one area of the beach, near the entrance. On the day of the visit, some shops were shut but the café was still open. However, many of the summer activity shops (selling buckets, spades and inflatables) were closed. This was because off season, these items are not generally 'sellable' therefore it would not be economical for the shops to open at that time of year. The beach itself was generally smaller than some of the other beaches that were examined. However, this beach had good disabled access. The litter on this beach could be attributed to dog walkers, with faeces being identified on the day of the survey.

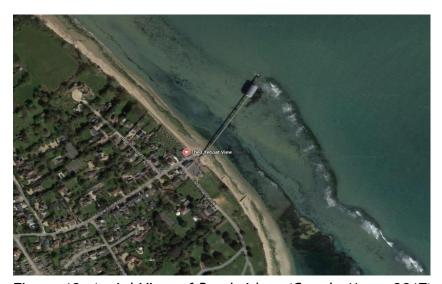
Figure 18: Aerial View of Bembridge, (Google Maps, 2017)

Bembridge beach is home to the RNLI lifeguard station, which dominates the beach landscape, as shown in Figure 18. This beach is mainly used by the local population, and during the visit it seemed to be less of a tourist beach, when compared to the other beaches which were assessed. This was shown by the lack of restaurants, sunbeds, shops, clean showers and fresh water taps. There was an absence of lifeguards, even though there is a RNLI base present. There were not any public information boards either, which would have helped to find about the restrictions and safety information. By increasing the safety at the site, this would improve the star rating, along with the construction of facilities at the beach. The litter score was 'B', and therefore more regular cleaning may be needed out of season to improve this, alongside implementation of bins and cigarette receptacles. This would also help improve the scenery value, as litter is counted towards the coastal scenic evaluation score.

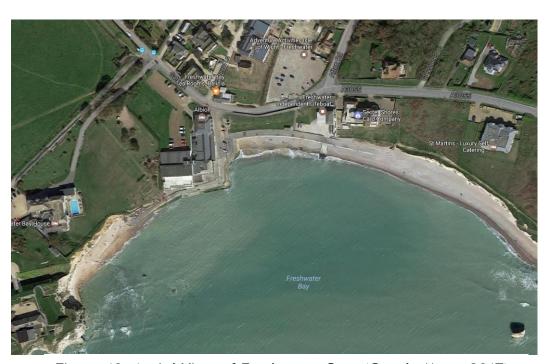
Figure 19: Aerial View of Freshwater Bay, (Google Maps, 2017)

At Freshwater Bay, there was limited development in the scenery parameter. There were a couple of small cafes, which were closed, alongside a shop and self-catering cottages, as shown in Figure 19. The beach had a sloped front, and this meant there was a build-up of rock material in some parts of the beach. In terms of safety, there was a lack of lifeguards and zonation, but there were notices and a safe bathing environment. Water quality, as with all the beaches was rated 'A'. There was a low level of human interference and traffic due to the lack of development. This also could have been due to the time of year. There was a relatively low amount of litter, but to increase the score to an 'A', regular monitoring and cleaning should be carried out.

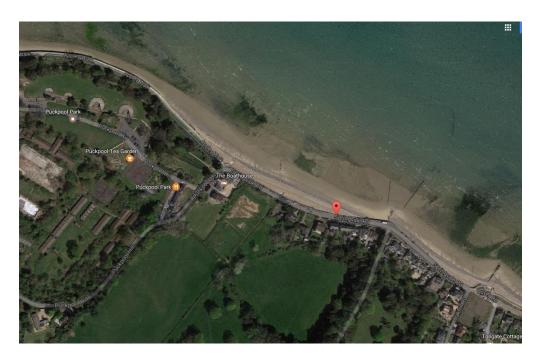
Figure 20: Aerial View of Springvale, (Google Maps, 2017)

Springvale is a shingle beach which had limited development around the area behind the beach, as shown in Figure 20. There was a woodland, and a restaurant across the road from the entrance to the beach, which was open on the day. Due to the size of the beach, there is no designated parking point. Cars park behind a wall which separates the road and the beach. This reflects in the scenery score of 'C' for this location. There were warning zones and safety equipment present, but there was a lack of lifeguard presence and marine zonation. As mentioned, there were restaurants and accommodation, but an absence of shower facilities. There were some isolated seaweed spots, which if cleared would improve the scenery score.

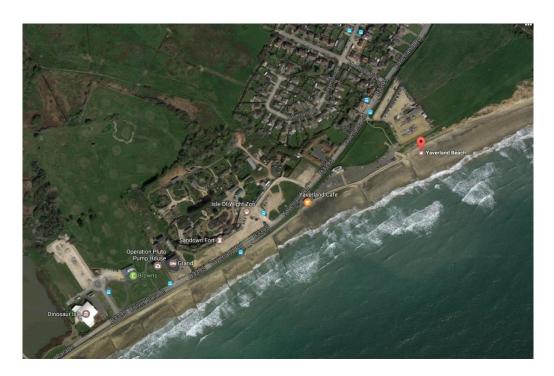
Figure 21: Aerial View of Yaverland, (Google Maps, 2017)

This site had many natural features, with little human development, as shown in Figure 21. The beach has large open areas of sand, and this allows for many activities and multi uses by visitors. The beach itself was larger than many of the other sites, and this means that there may have to be more time taken for litter cleaning. There was a restaurant and adequate parking at the site. Despite there being nearly all safety features present, there was no lifeguard service and this brought the safety score down. There was accommodation, but no public shower facilities. The beach scenery score was affected by the lack of buffer zone between the road and the beach, this meant that noise from the road could be heard, and vehicles could be seen from the beach.

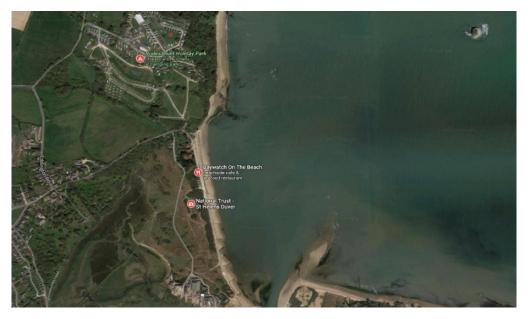
Figure 22: Aerial View of St. Helens, (Google Maps, 2017)

This location was categorised as a rocky shore, which allows for rock pooling in the summer seasons. There was a camp site at the back of the beach site, (as shown in Figure 22) however due to the lack of development in the area and absence of tourist shops and activities, it was classified as a village beach. There was a slight buffer zone separating the vehicles from the beach, however, they can still be seen from the beach site. Accommodation and a café were present, however there was an absence of public showers. The litter score here was excellent, and to continue this, regular cleaning should occur. There was a National Trust site, which may explain the lack of development towards the lower part of the beach.

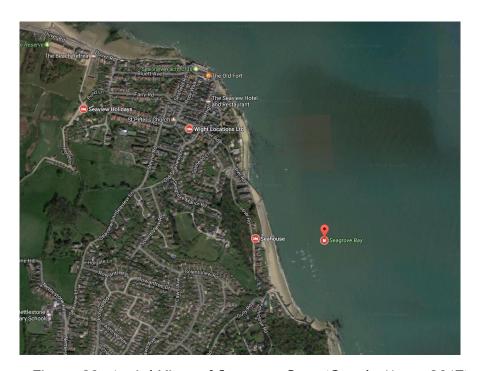
Figure 23: Aerial View of Seagrove Bay, (Google Maps, 2017)

Seagrove had limited development around the beach area, as shown in Figure 23. There is a popularity for water sports and motor boating in this area. The safety parameter is not applicable when assessing rural beaches, therefore it has not been analysed, and the same is true for facilities. There were no signs of human impact on the beach, but the road caused some noise at this location. Hard concrete groynes were present, and these could be replaced by wooden groynes to improve the aesthetics of the area.

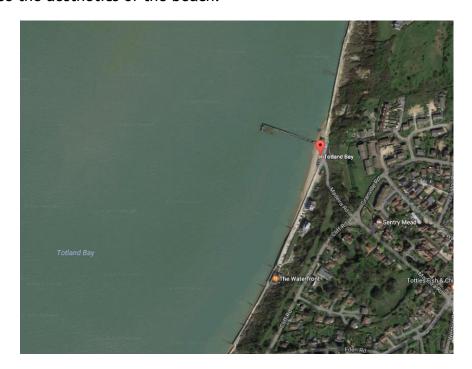
Figure 24: Aerial View of Totland Bay, (Google Maps, 2017)

Totland Bay had number of natural aspects, with a sand and shingle beach and pier, shown in Figure 24. Due to this, there was a lack of human influences on the beach, when compared to others in the assessment. The facilities here do not count towards the overall grading, but a café was present. The only area to improve is scenery. To do this, a buffer zone needs to be created to increase the aesthetics of the beach.
