## Beneficial Use of Dredged Sediment to Improve Boiler Marsh, Lymington

Review of restoration activities and monitoring undertaken for the first trial campaign in 2024

February 2025

| Document History and Authorisation | | |
|---|---|---|
| <b>Document ref</b> | R.4757 | |

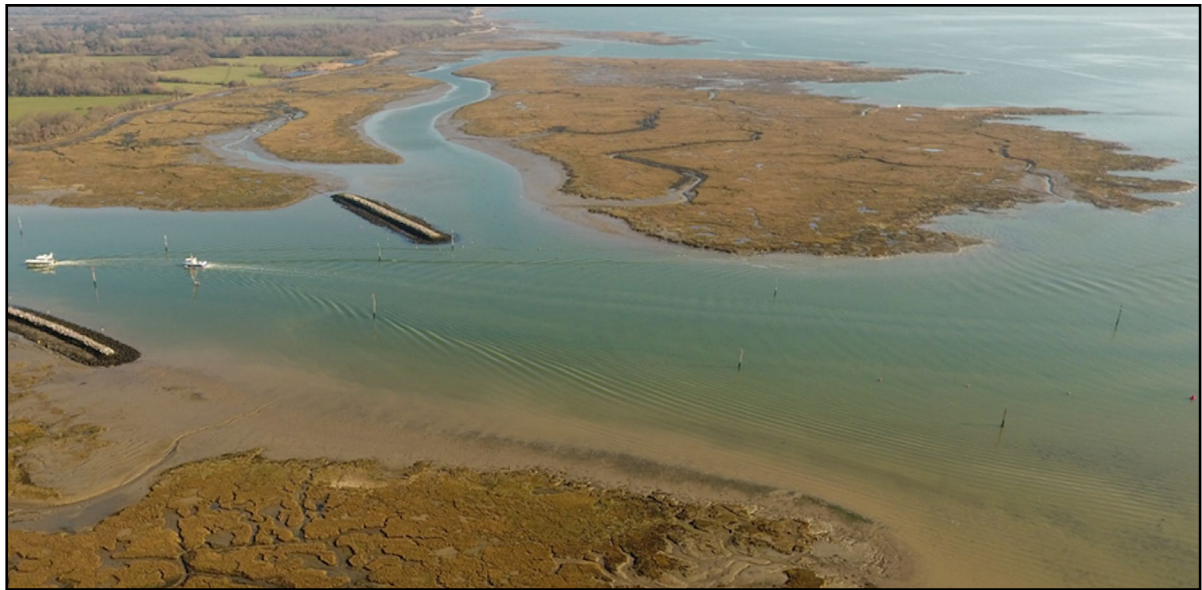
**Image 1. View of Boiler Marsh in front of Lymington Harbour**

This restoration area was once covered in saltmarsh plants but is now unvegetated and in an ecologically poor condition. To return vegetation to this area, dredged sediment is being used to raise the intertidal bed level so that it matches, or even exceeds, the height of the surrounding healthier marsh. The intention is to expand the healthier vegetated marsh and provide much needed habitat for breeding seabirds as well as help delay the loss of this large eroding marsh island.

Marine Licence L/2023/00294/1 provides consent for Lymington Harbour Commissioners (LHC) to restore of up to ten hectares (ha) of saltmarsh on Boiler Marsh island which lies at the entrance to Lymington Estuary (see Figure 1 and Image 1). Under this licence, LHC is working with Land and Water Services Ltd (LAWS), the Hampshire and Isle of Wight Wildlife Trust (HIWWT) and other stakeholders to raise the bed elevation of an ecologically deteriorating central part of the island.

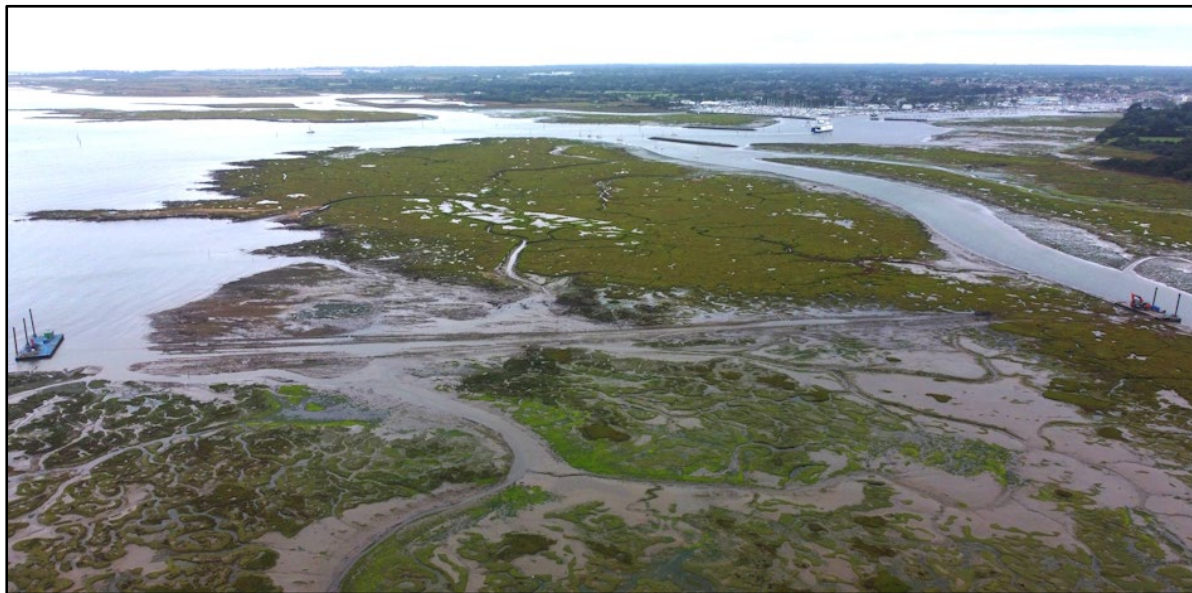
Image 2. Central and west side of Boiler Marsh during the drag box activities

For this first campaign the sediment movement was done using a new Saltmarsh Restoration Drag Box (SRDB) technique. This technique involves drawing a steel 'drag box' with load bearing skis along a winch line from the low to the high shore. The winch line is held between pulleys on a spud barge moored temporarily to seaward of the dredge sediment placement area and an excavator positioned on the landward side of the receiving/restoration site (see Image 2).

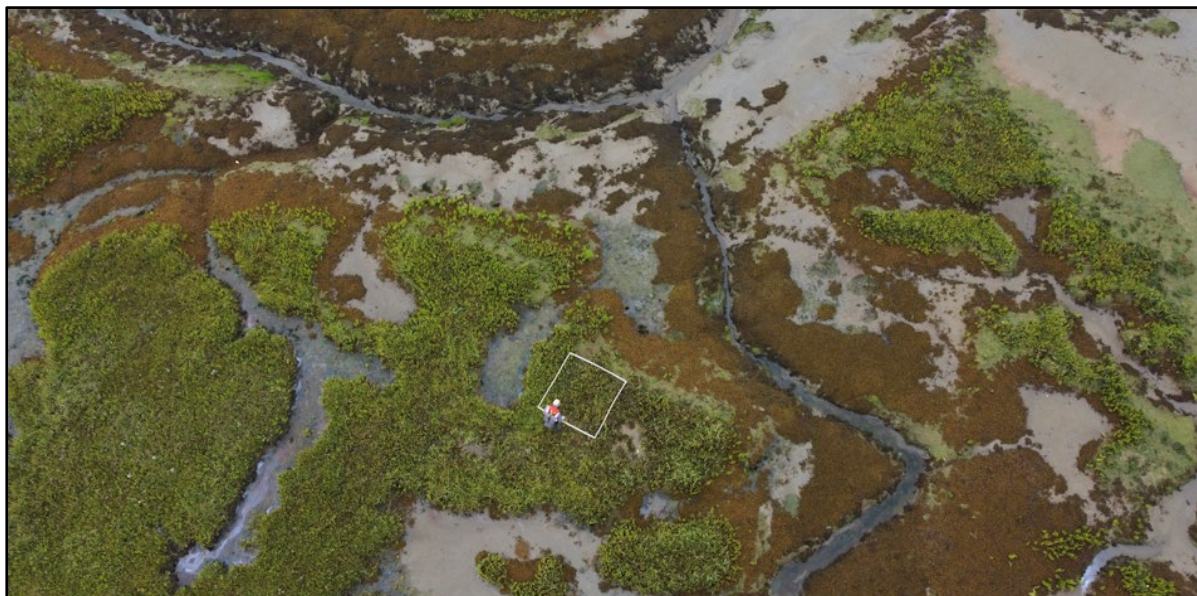
Image 3. Aerial view of 4 m<sup>2</sup> quadrat site for recording saltmarsh plant cover

During this survey, the percentage cover of marsh plants was recorded at the six established quadrat recording locations (Sites Q2 to Q7). An example of one quadrat sampling site is shown in Image 3; and the site locations are illustrated in Figure 5.

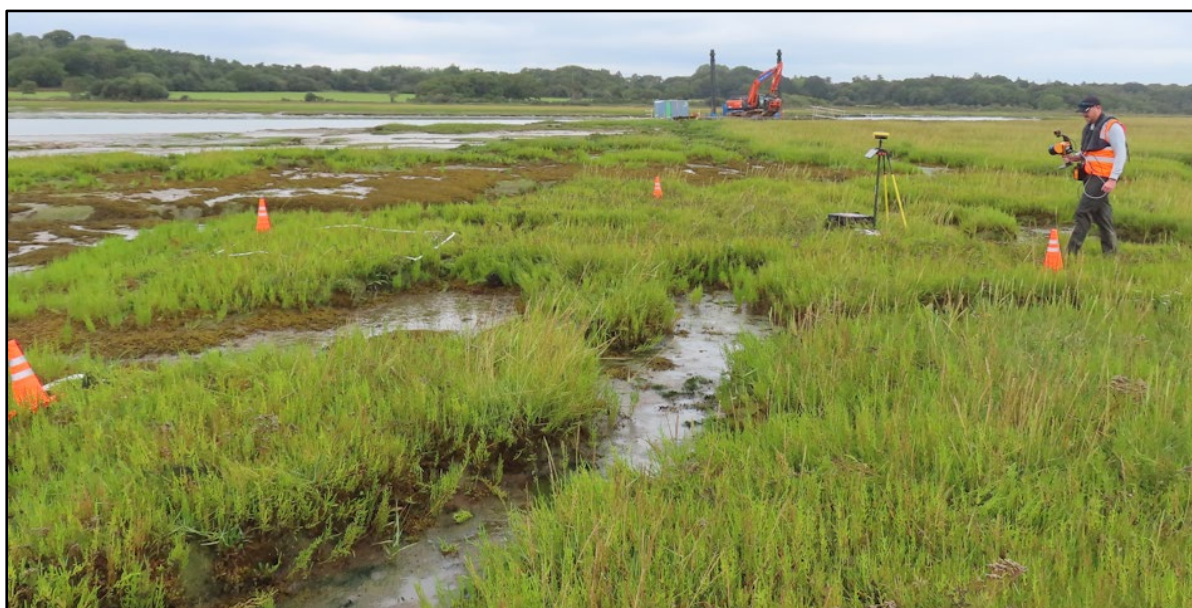
**Image 5. GeoSLAM 3D LiDAR topography and photogrammetry mapping at Site Q3**

using a GeoSLAM 3D Light Detection and Ranging (LiDAR) and photogrammetry scanner (see Image 5). These extra GeoSLAM readings were taken, in large part, to explore the value of using this approach on saltmarsh habitats.

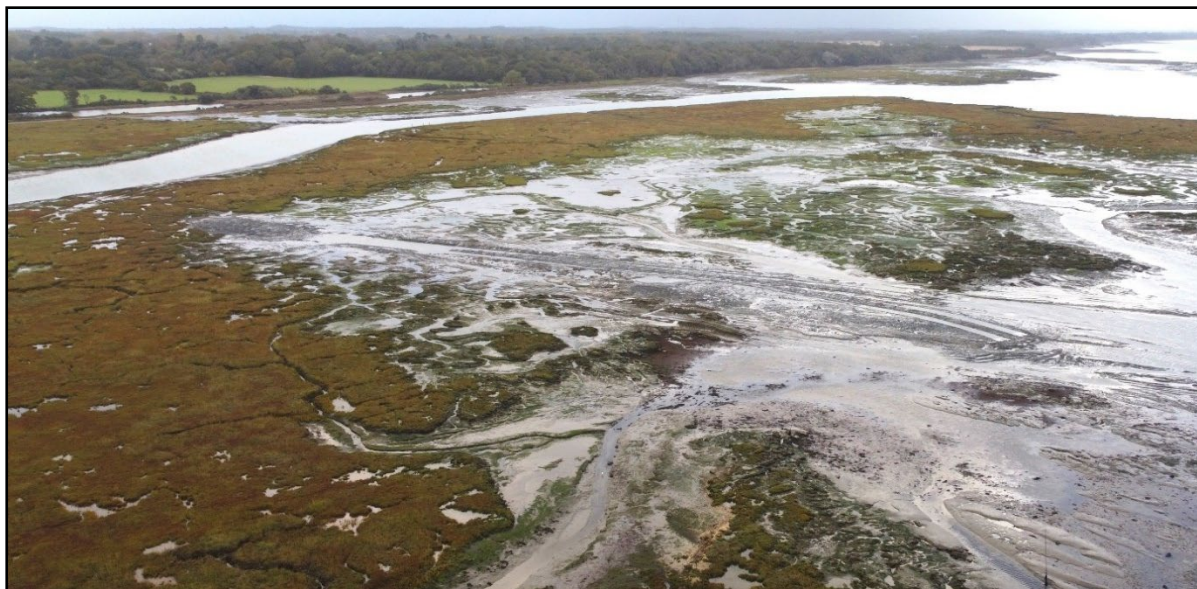
Image 6. Aerial view of whole restoration area from west

These two areas, as well as the regions where the excavation occurred are illustrated in Figure 8 which shows the areas of bed elevation differences in the restoration areas between April and October 2024. To also illustrate the outcomes on site, an aerial view of the whole working area after the trial was completed (as taken on 8 October 2024) is shown in Image 6.

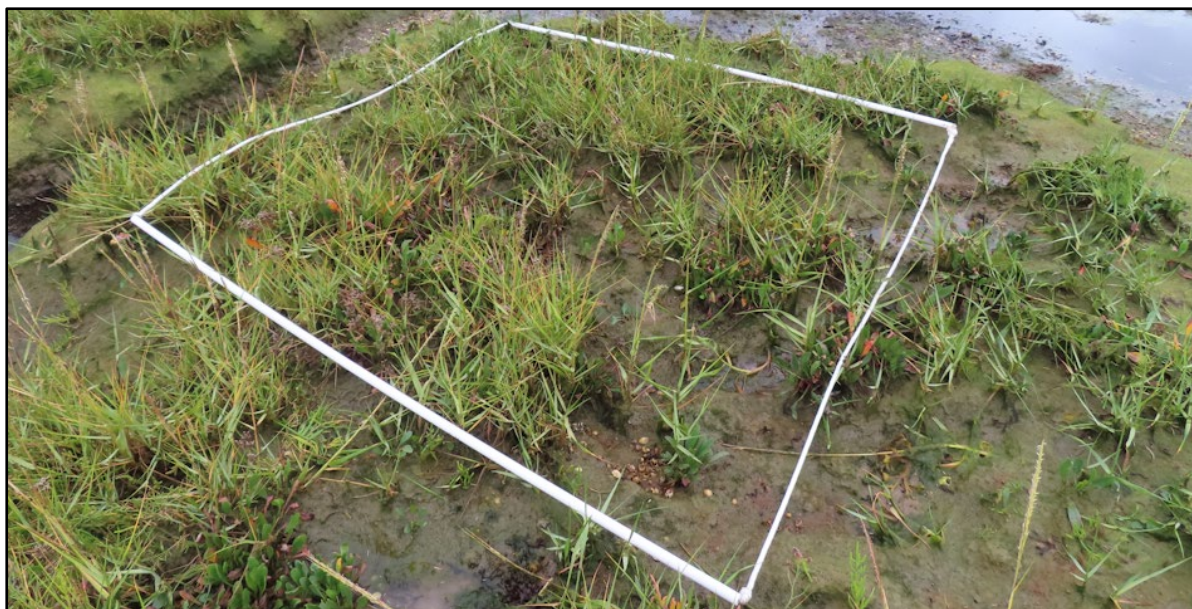
**Image 8. Deteriorating internal marsh edge with mainly Spartina at Site Q2**

situation and this change will reflect a process of ongoing internal marsh edge deterioration due to increasing tidal inundation, exposure and other physical and biological stresses.

- **Site Q2:** This is a relatively lower lying (at 0.92 m ODN) and exposed site that has shown signs of deterioration and decline in plant cover over just the two years between 2022 to 2004 (as described above);

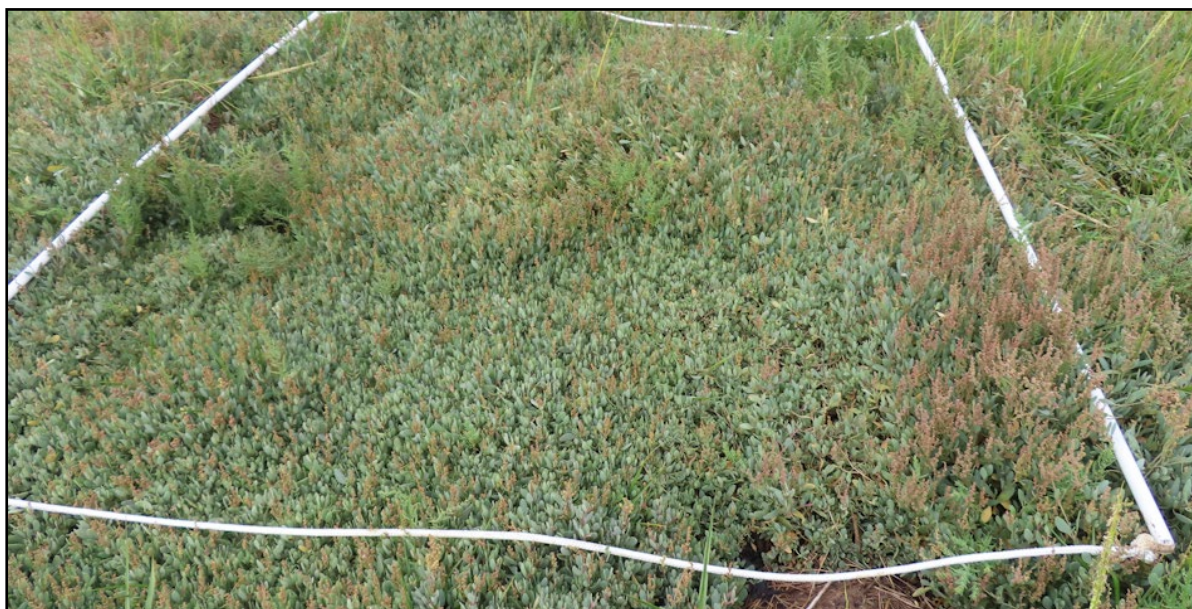
**Image 9. Sea purslane dominated marsh at Site Q6**

- **Site Q6:** This is the highest lying site (at 1.24 m ODN<sup>6</sup>) and because it lies next to a channel it is well drained and characterised by sea purslane<sup>7</sup>. This habitat is ideally suited for nesting waterbirds, and one of last season's nests lies at the edge of the quadrat (see Image 9);
- **Site Q7.** This site has the greatest range of species (seven recorded in 2024 and, like Q6, a dense 100% coverage of plants. It is similar in elevation to Q4 (at 1.05 m ODN) which again shows the value of even modest increase in bed elevation relative the exposed marsh fringes.
